Report No. NA-69-37
(RD-69-46)

EFFECT OF GROUND CRASH FIRE ON AIRCRAFT FUSELAGE INTEGRITY

DECEMBER 1969

**DEPARTMENT OF TRANSPORTATION
FEDERAL AVIATION ADMINISTRATION
National Aviation Facilities Experimental Center
Atlantic City, New Jersey 08405**

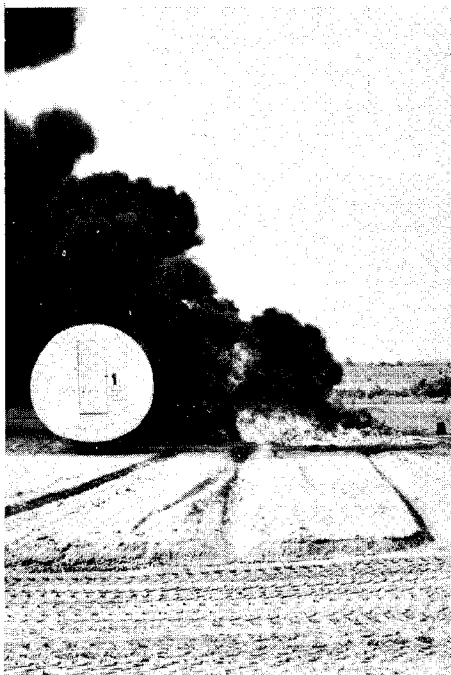
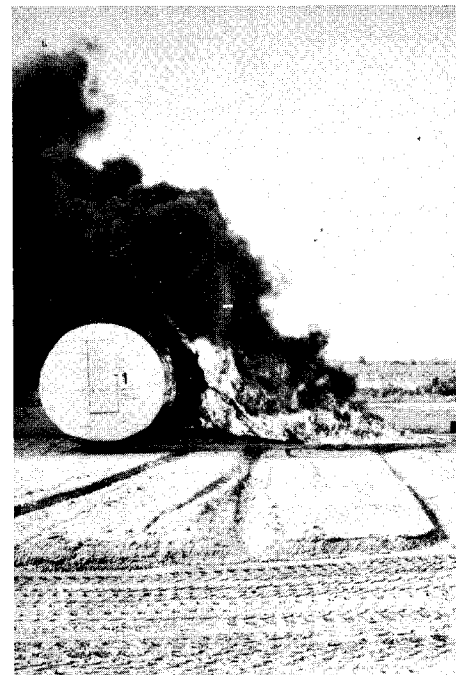
(a) Fire Pit Location

(b) Fuel Ignition

(c) Burning Time 10 Seconds

(d) Burning Time 30 Seconds

FIG. 7 EFFECT OF WIND ON POOL FIRES

During the course of the stainless-steel-covered fuselage experiments, the effect of wind on free-burning pool fires (Reference 1) was evident and is considered to constitute an important factor in tactical aircraft firefighting techniques. The effect of wind is to bend the flame in the downwind direction, and the flame angle is a function of the wind velocity. The flame angle is defined as the angle of tilt of the flame from the vertical. The flame-trailing effect around the test article is shown for wind velocity of 6 to 8 mi/hr in Figure 7. In this test, the downwind edge of the fire pit was 20 feet from the centerline of the fuselage. Photographs (c) and (d) of Figure 7 show the large increase in the effective width of the fire caused by the flame-trailing phenomenon, and it will be noted that the flames are in actual contact with the fuselage. The temperature data presented in Appendix I, Test No. 1, Figure 1.5, show that the stainless steel skin temperature at Station T_d reached a maximum of 860°F in approximately 100 seconds after fuel ignition while the ambient air/flame temperature outside the fuselage rose to 1200°F in 30 seconds after fuel ignition.

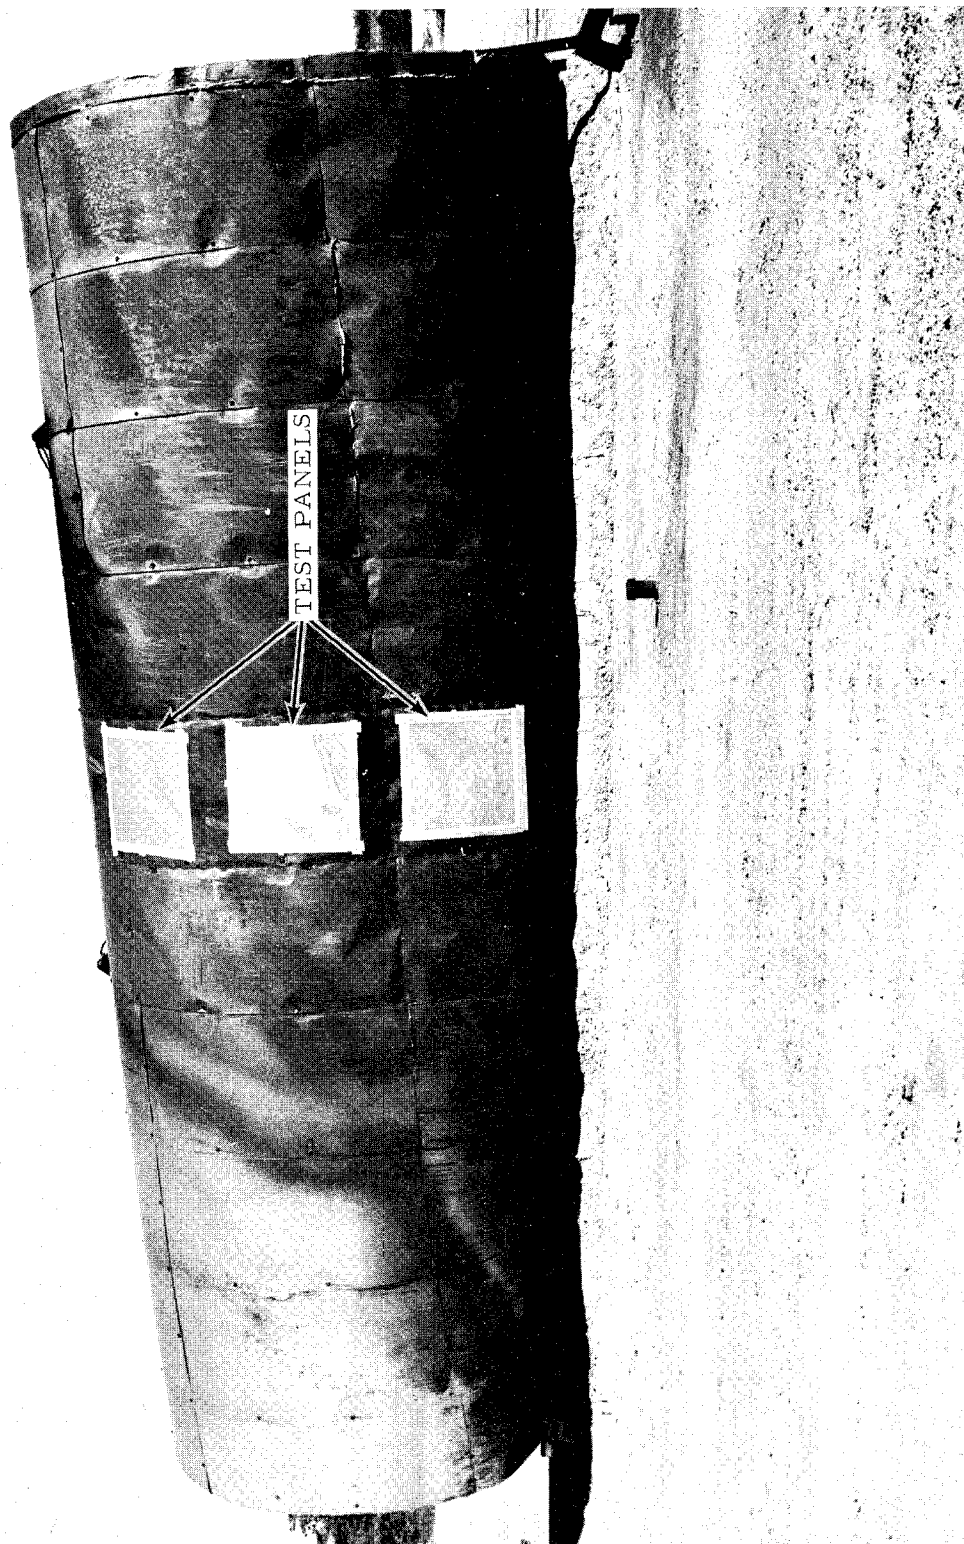
FIG. 11 EXTERIOR VIEW OF THE TEST PANELS IN POSITION

Description of Tests: The second series of tests employed four different thicknesses of standard aluminum aircraft paneling inserted in three openings, 3 by 3 feet, cut through the fuselage and steel covering. Two of the four tests employed panels constructed of Alloy 2024-T3 conforming to Federal Specification QQ-A-362 (Alclad). One was 0.016 inch thick (Test No. 5), and the second was 0.040 inch thick (Test No. 6). The other two panels were constructed of Alloy 7075-T6 (Alclad) conforming to Federal Specification QQ-A-287 and were 0.020 inch thick (Test No. 7) and 0.090 inch thick (Test No. 8). Each panel was backed by a 2-inch-thick layer of "AA" fiberglass insulation with a density of 0.60 lb/ft³ backed with a facing of polyvinylchloride. This configuration was designed to approximate standard aircraft construction and to provide all of the essential parameters necessary to verify the validity of the mathematical model. A cross-sectional drawing of the test panel construction is presented in Figure 8 and photographs of the instrumented panels in Figures 9 and 10. An exterior photograph of the fuselage section with panels installed for testing is shown in Figure 11.
